# Intel® 6300ESB I/O Controller Hub (ICH)

Specification Update

*October 2007*

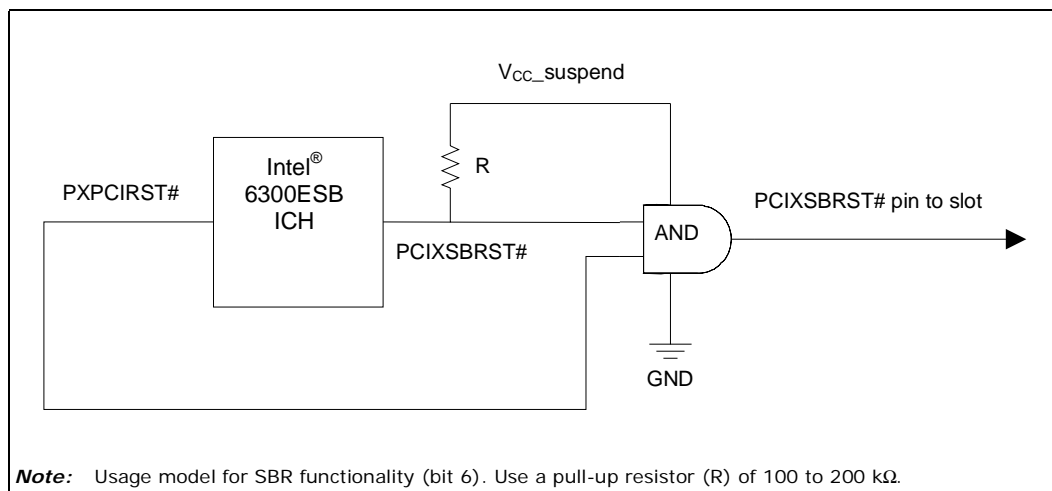
**Figure 1. Board Workaround for PCI-X Secondary Bus Reset Functionality**

**Problem:** The Secondary Bus Reset pin (PCIXSBRST#) on the PCI-X bus is internally tied to the Vcc\_core well. When the system goes into S3 state (sleep), this signal is floating due to Vcc\_core going away.

**Implication:** System will not WOL when PCIXSBRST# is connected directly to the PCI-X slots.

**Workaround:** A board workaround pulls the PCIXSBRST# pin up to Vcc\_suspend through a resistor (R). This pin is also ANDed with the PXPCIRST# pin so that if the PCI-X bus resets, the signal that is routed to the slot reflects the reset. Also, since the AND signal is powered by Vcc\_suspend, when the system goes into sleep state (S3), this voltage is still present and the correct voltage is applied to the signal that is routed to the slot. See Figure 1 below.

**Status:** No fix. This board workaround is to be used if customers plan to utilize this SBR feature. If not, the PCIXSBRST# pin is to be not connected.
